Understanding Spur Gear Life

TRSM0913

Mechanics of a Spur Gear

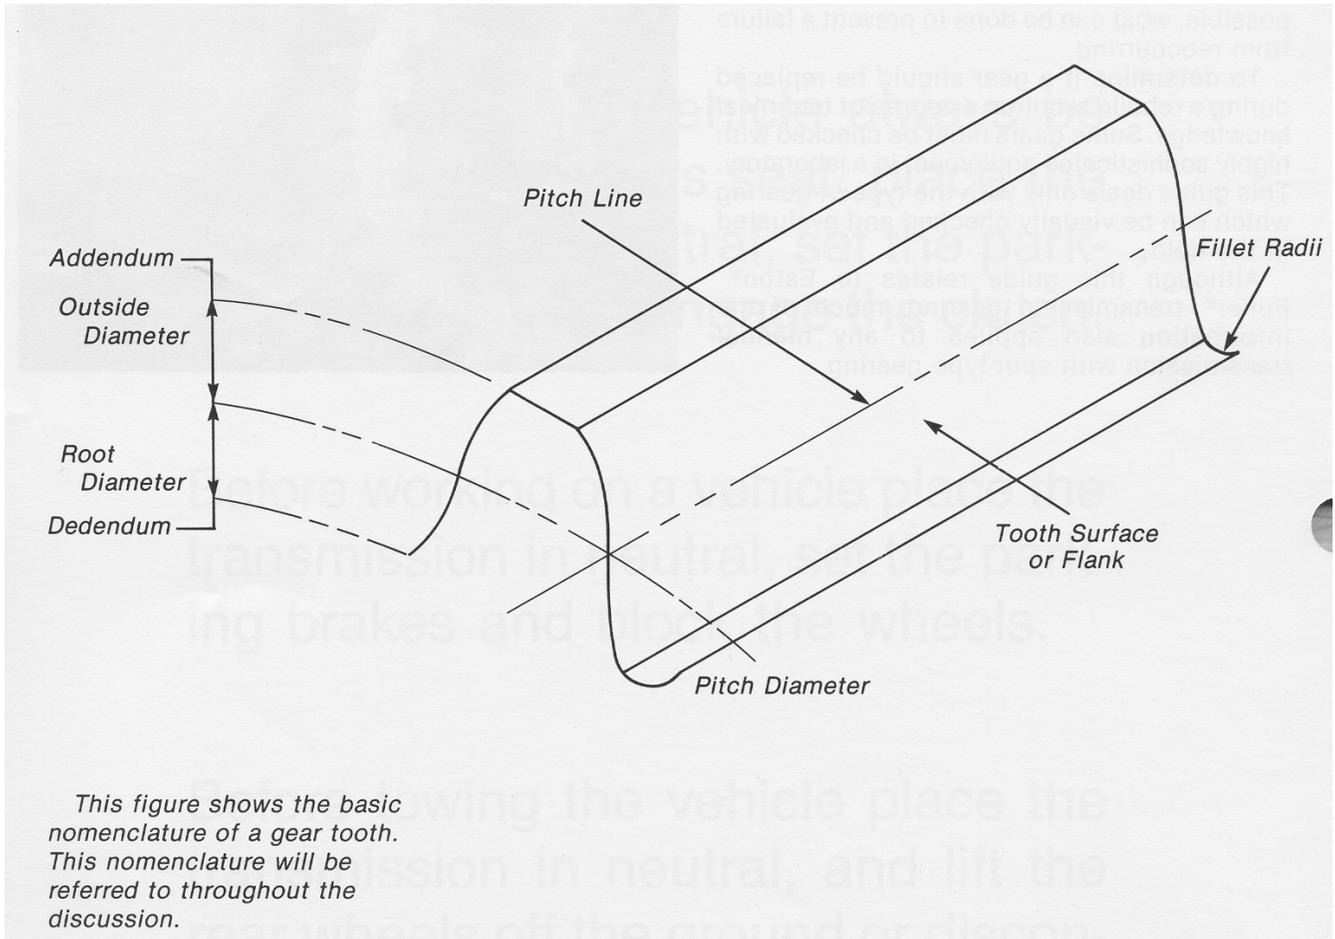
Tooth Nomenclature

To better understand the following sections of this guideline, a description of tooth nomenclature and operation, as well as tooth design and manufacturing considerations, is provided.

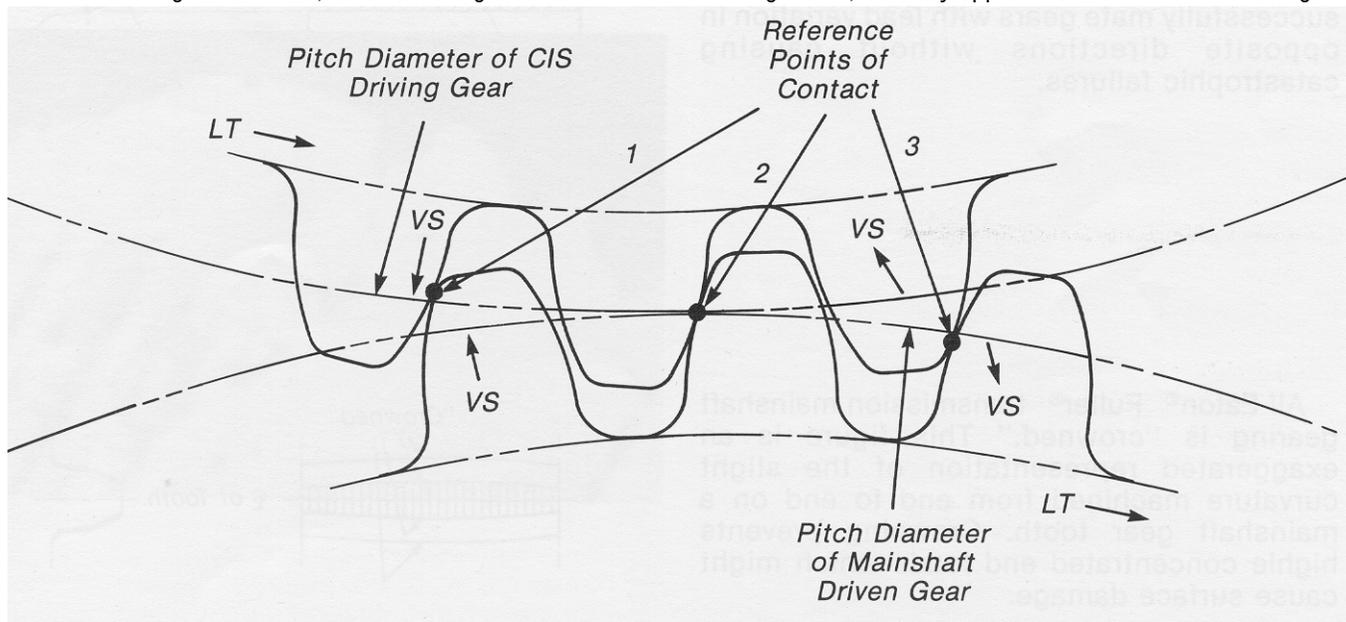
Three Stages of Tooth Contact

The teeth of two gears during operation (or mesh) pass through three stages of contact:

1. Coming into mesh, initial contact occurs in the dedendum (lower) portion of one tooth (on the driving gear) and in the addendum (upper) portion of the mating tooth (on the driven gear). At this point of torque transfer, tooth loading (LT) is relatively light, since most of it is carried by the teeth in full mesh and a portion by the teeth going out of mesh. Contact between the two teeth moves in a sliding action as they proceed through mesh. The sliding velocity (VS) decreases until it is zero when the contact points reach the intersection of their common pitch lines.
2. At full mesh, the two teeth meet at their common or "operating" pitch line, there is only a rolling motion, no sliding. However, this stage produces the greatest tooth loading.
3. Coming out of mesh, the two mating teeth also move in a sliding action, basically opposite of the initial contact stage.

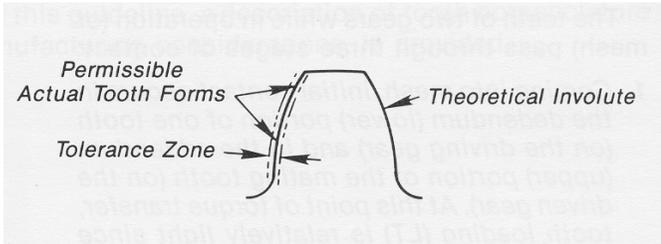
An ideal tooth shape is designed for each gear. Since it is impossible to make a perfect part, Eaton Transmission Division Engineering has determined manufacturing tolerances that will not shorten a gear's life. This figure is only an example of these tolerances, as the tooth form will change according to various design limitations. The actual tooth profile can fall anywhere with the tolerance band.

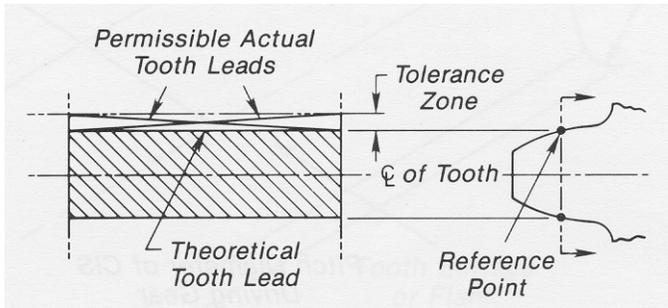
A gear tooth is also designed to be parallel with the centerline of the shaft. As with the tooth profile, certain acceptable tolerances have been determined, as shown in this figure. These close tolerances make it possible to successfully mate gears with lead variation in opposite directions without causing catastrophic failures.

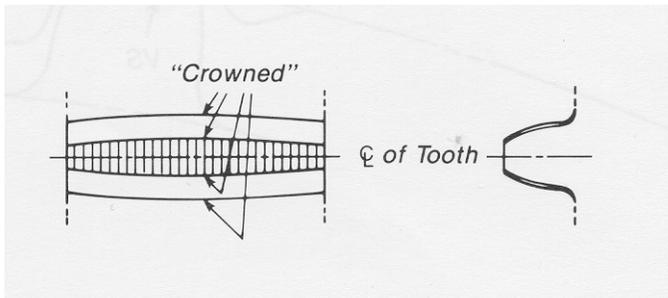
All Eaton® Fuller® transmission mainshaft gearing is "crowned". This figure is an exaggerated representation of the slight curvature machined from end to end on a mainshaft gear tooth. Crowning prevents highly concentrated end loads which might cause surface damage.

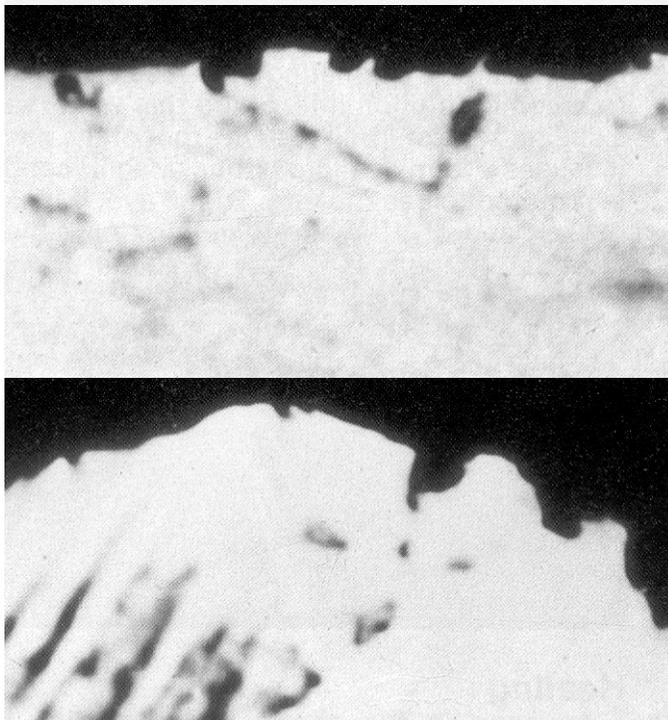
Under magnification, even the smoothest looking surface has irregular hills and valleys. This is illustrated by the two comparative photos magnified 600 times. The top photo shows the pilot bearing surface of the input shaft (.127 mm).

The bottom photo shows the surface of a gear tooth. In both photos, the width of the surface shown is approximately .005 inches

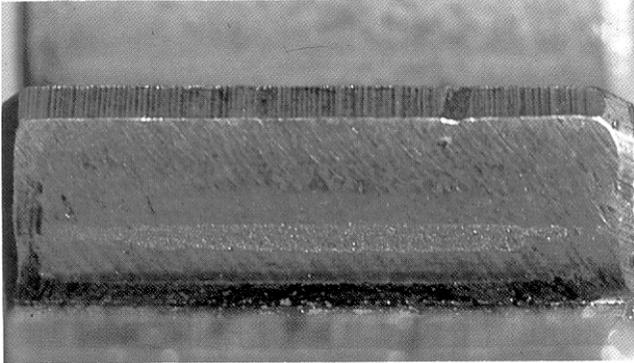
Frosting

As noted before, during mesh specific areas of the tooth surface are in contact during each stage. However, variations in the tooth form between mating teeth may produce a slight change in the contact pattern. This will result in light wear as the mating gears seek to adjust to a common pitch line. Since this wear is in a sliding zone starting near the root of the gear, it causes a form of micro-pitting. Magnification is required to see the pits. To the eye, it looks like a band of off-white discoloration called “frosting”. There is a lack of sheen at this stage.

A gear should not be replaced simply because of frosting. But if it also shows other signs of distress, such as tip loading, misalignment, severe surface irregularities, etc., then further investigation is needed. These signs will be discussed later.

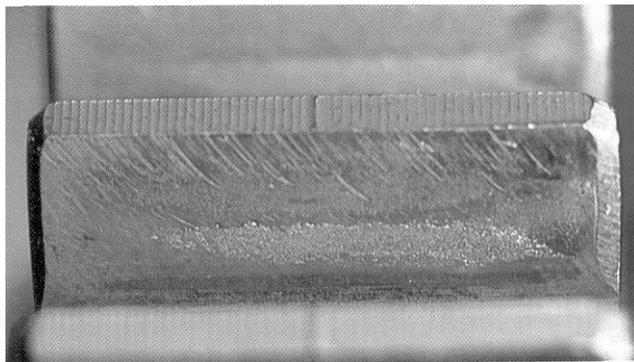
Offset Frosting

As previously stated, there are acceptable tolerances in tooth lead. Mating gear teeth can successfully operate with lead variation in opposite directions. However, a small amount of load shifting may occur. Slight wear may take place until the load is again evenly distributed across the entire tooth width. This may also result in frosting in the dedendum portion and sometimes in the addendum portion of the tooth, offset from the tooth center. Again, under normal conditions, healing will take place and gear life will not be lost.

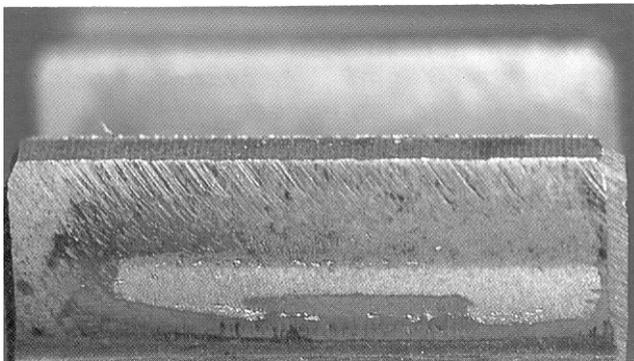
Healing

As seen in the photo, the pitch line is generally well defined. The balance of the frosting will take the shape of the contact area, no matter what it might be. Under normal conditions, the contact zone wears away; the rate of wear decreases until the point is reached where it polishes itself out and the frosting is totally replaced by a very shiny area. No further wear takes place. This is called “healing” and absolutely no gear life is lost at this stage.

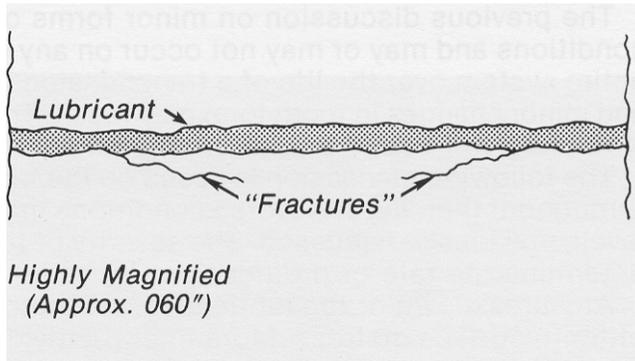
Gear Pitting

There is another surface condition which is normal in the early life of a gear and common in any carburized involute spur gear. It is the result of microscopic variations in tooth form and surface material microstructure.

Lubricant normally fills the irregularities of both teeth while in mesh. Lubricant builds a film of oil and no metal-to-metal contact takes place. Under load, oil pressures and surface stress develop between the teeth. The specific cause of this stress is debatable. One theory is that repeated high horsepower applications may cause oil pressures sufficient to overstress the microscopic areas of the tooth surface. Small surface fractures may start, and repeated loading may increase the fracture until the area is weak enough to break out, forming a pit.

The pit size will vary, depending on the depth of the initial fracture and how far the pitting has progressed. The pitting will progress until the tooth can carry the load without further distress. This rarely exceeds "initial" pitting and the distressed areas can heal

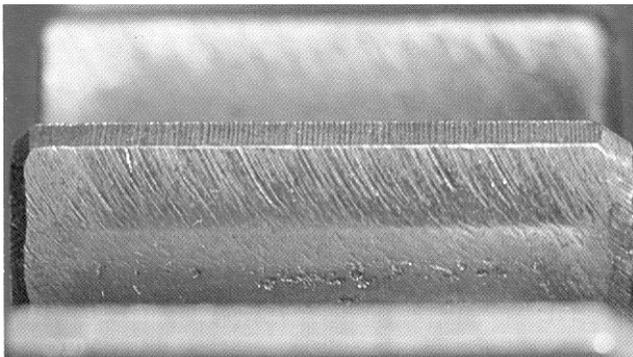
Initial Pitting

"Initial pitting" is the mildest stage of pitting. It consists of definite pits from pin hole size, just larger than frosting and barely noticeable to .030 inches (.762mm) in diameter.

Generally, initial pitting continues until the tooth is able to carry the load without further distress. Do not replace a gear because of initial pitting, as it will not cause noise and in many cases will heal over.

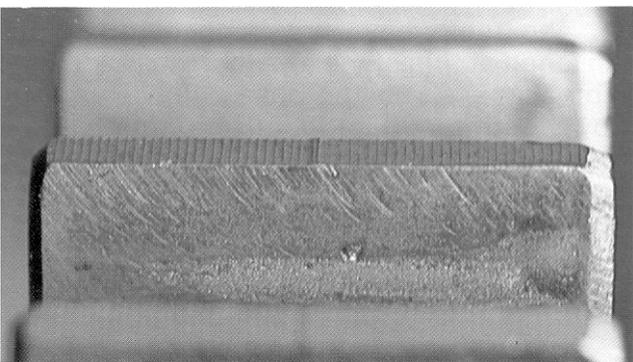
Combinations

You can see under normal operation, a gear can have a "combination" of tooth distress, frosting and/or initial pitting. Again, all are likely to heal over.

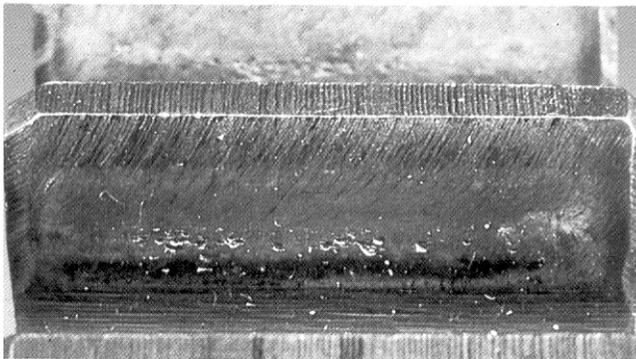
Moderate Pitting

This gear shows pit craters approximately .060 inches (1.524mm) in diameter and .005 to .010 inches (.127mm to .254mm) deep, about twice the size of craters in initial pitting. The pits are widely distributed across the face of the tooth. This gear has lived about 50% of life. The teeth have not been significantly weakened at this stage and there is no danger of breakage. As in the case with gears that show frosting and initial pitting, this type of “moderate pitting” will not cause noise. This gear can give many more miles of useful service.

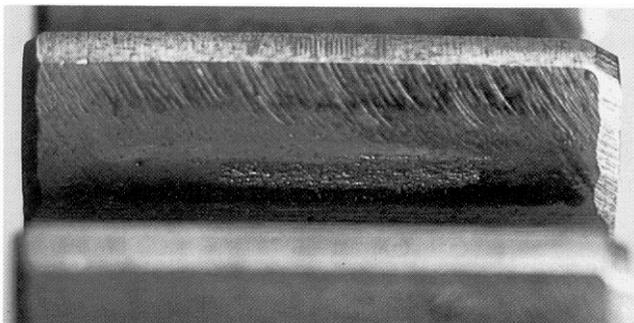
This gear also has pitting on approximately 50% of the tooth surface, but unlike the previous gear shown, this gear should be replaced. The pitting is concentrated and at the pitch line, which changes the involute form. Although the teeth have not been significantly weakened, noise can be generated because the involute form no longer falls within the tolerance band discussed earlier.

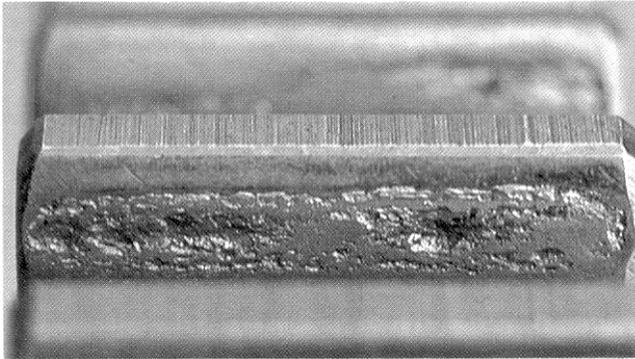
Destructive Pitting

The pitting on this gear is well advanced into a “destructive” stage. The pit craters are considerably larger and deeper than those in moderate pitting. Gears in this stage of pitting should be replaced, or noise and fatigue fractures may occur.

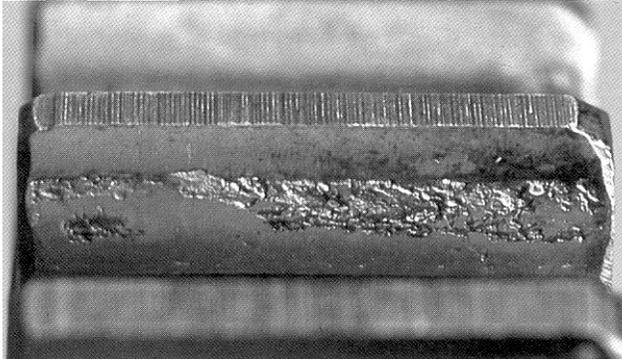
“Spalling” is similar in appearance to destructive pitting except the craters are larger in diameter and shallower in depth. Spalling occurs over a short period of time when a gear is subject to an extreme overload condition.

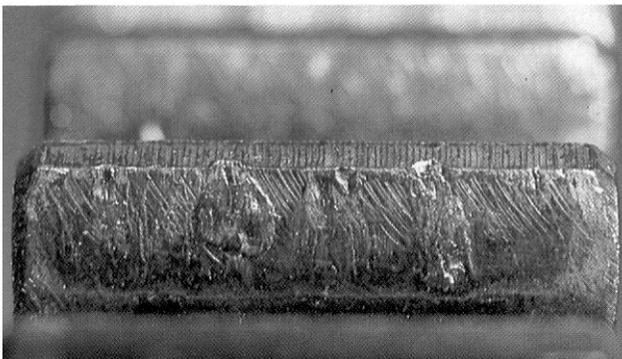
Scoring

“Scoring” is caused by an insufficient oil film between mating gear teeth, resulting in very high surface temperatures. This results in an alternate welding tearing of metal which is rapidly torn from the tooth surface. Insufficient oil film can be caused by: Low oil level, excessive transmission operating angles, high operating temperatures, poor quality, incorrect viscosity oil, and by mixing types of oil.

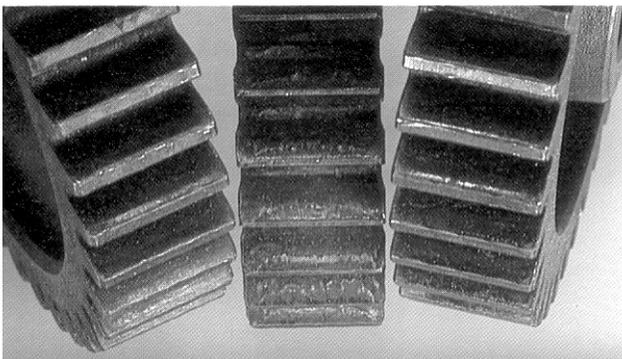
Burned Head Set

When inspecting a transmission with a “burned head set”, it is not unusual to find the main drive gear badly scored, with only slight visible damage to the mating countershaft drive gears. This occurs because the teeth of the main drive gear make contact almost three times as often as the teeth of the mating countershaft drive gears. When replacing a burned main drive gear, also replace the countershaft drive gears, even if there is no visible damage.

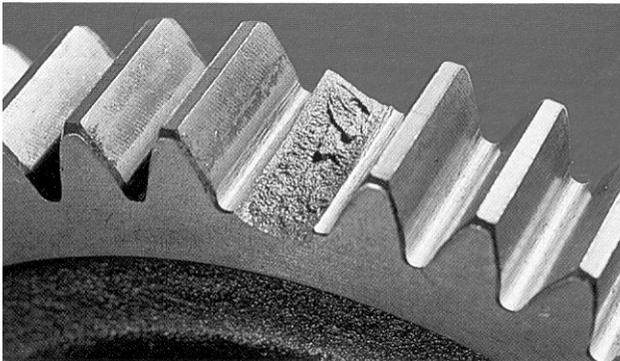
Impact Fractures

“Impact fractures” are caused by a severe shock load or a foreign object passing through the gear mesh. They are identified by a “bump” on the compression side of the fractured area. The more cycles the gear has run after the fracture, the smaller the bump will be. In addition to the gear which has a tooth fracture, the other two gears of the set should also be replaced, even though they may look undamaged. All gearing in the transmission should be inspected for possible damage caused by the broken tooth running through the transmission.

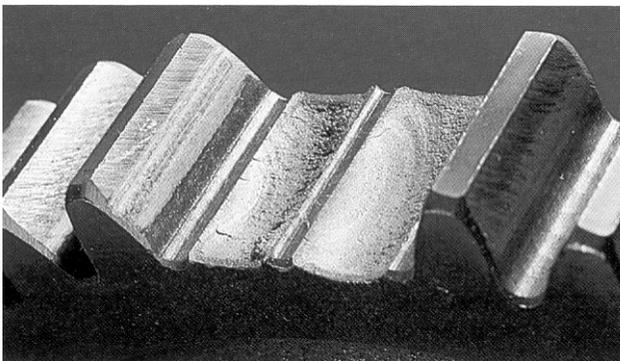
Fatigue Fractures

“Fatigue fractures” are caused by extremely high stresses on a gear tooth over a period of time.

Possible causes of such stresses could be:

- Shock loads causing a small crack in the tooth.
- Tooth damage from objects going through the gear mesh.
- An overload condition.
- Forging imperfections, excessive machining marks, or improper heat treatment.
- Severe pitting or surface fatigue.

Fatigue fractures are identified by “beach” marks on the fractured area. These marks are made as the tooth progressively cracks under a load heavy enough to enlarge the crack but not great enough to break the entire tooth off at one time.

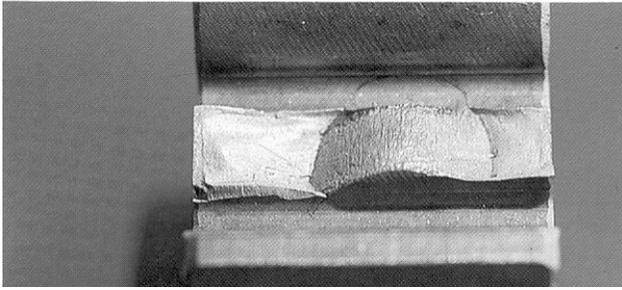
Stingers or Gas Pockets

Gears made from base metal which contain “stringers” or “gas pockets” have weak points at those areas. These fractures can be identified by the difference in fracture shape and metal texture in the break surface. Again, as with other fractures, inspect all gearing in the transmission for possible damage.
